# BUREAU OF SHIPS GROUP

## TECHNICAL INSPECTION REPORT

## WELDING

### OPERATION CROSSROADS

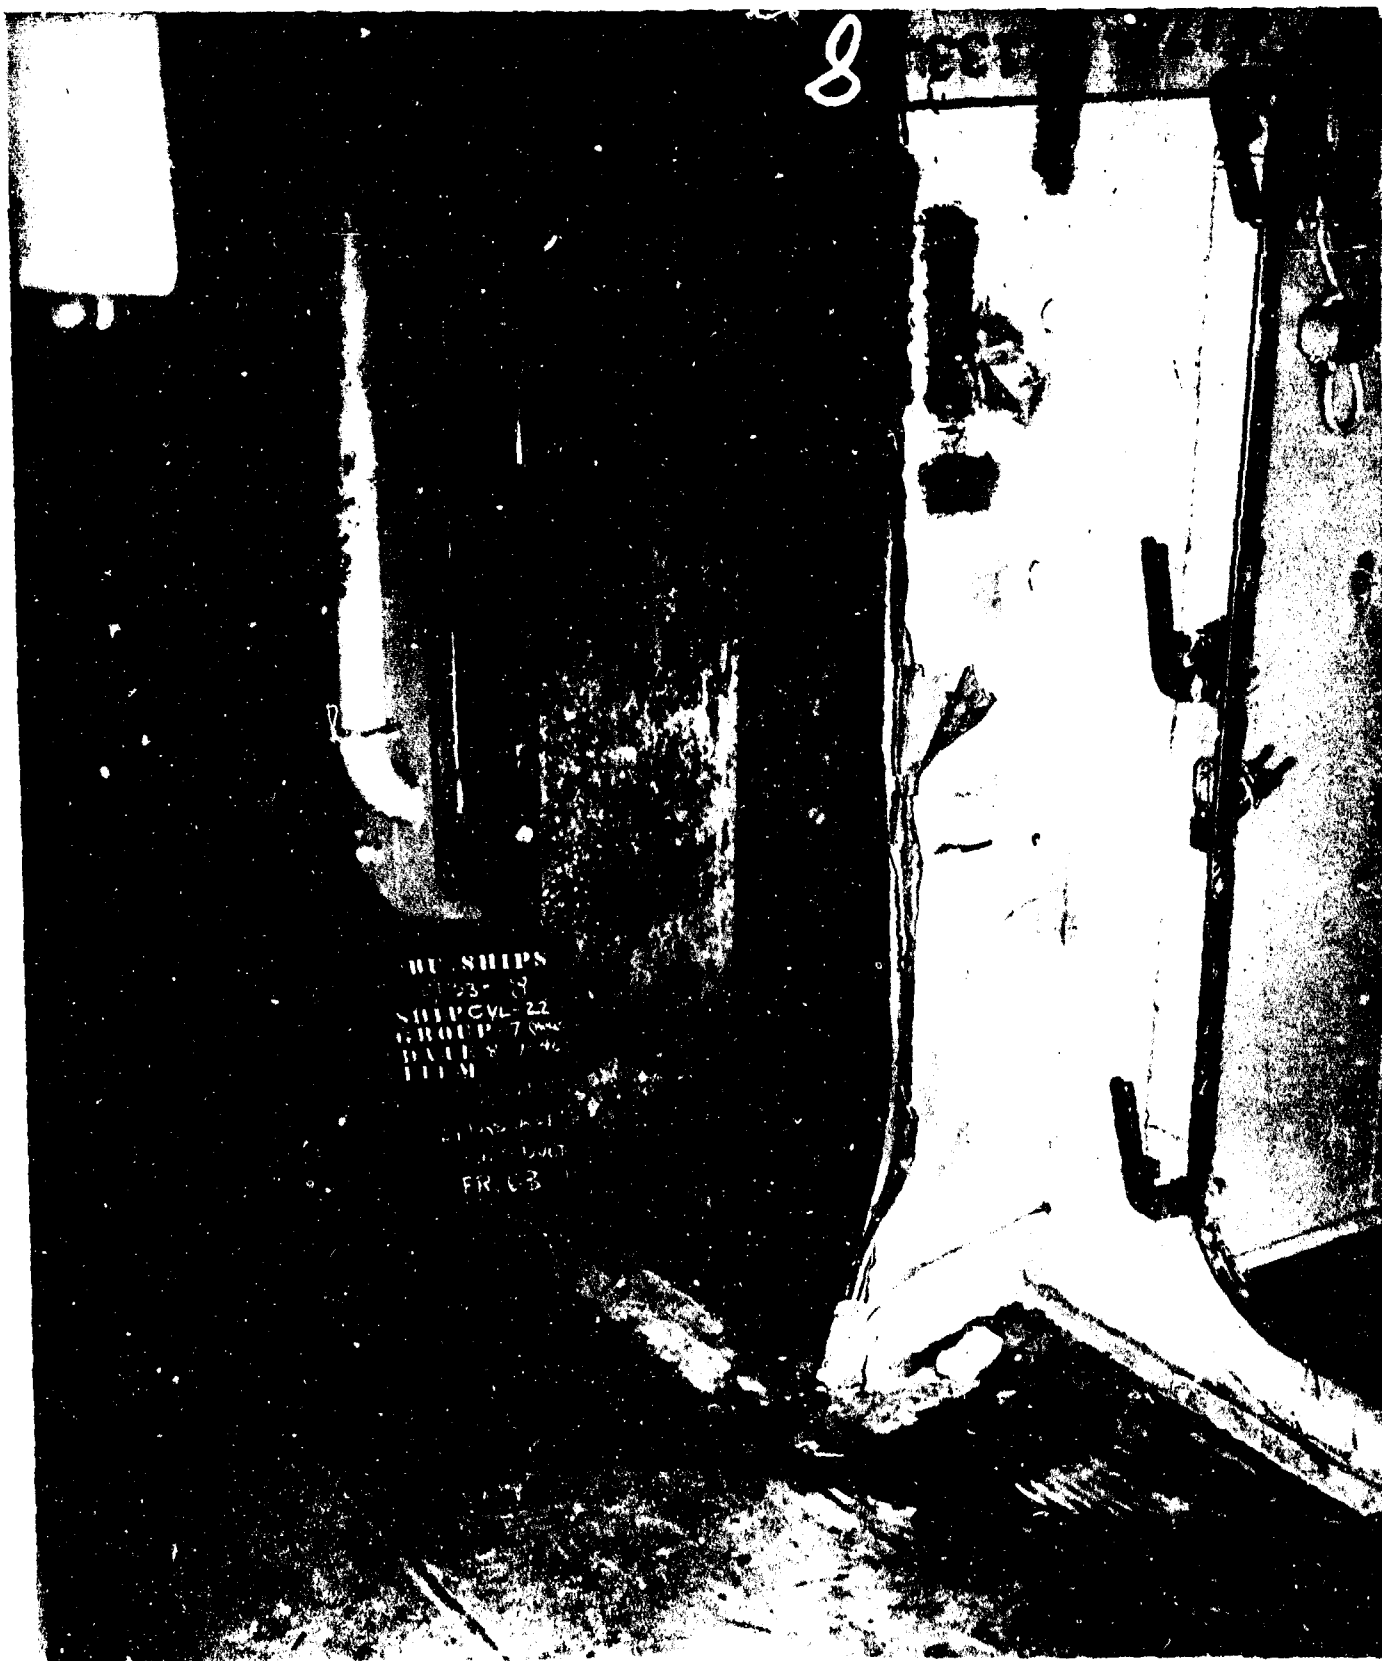
AA-CR-175-2133-8. USS INDEPENDENCE (CVL22). Failure of arc welded ventilation duct. Second deck, port passage, frame 63. Blast penetrated ventilation system.

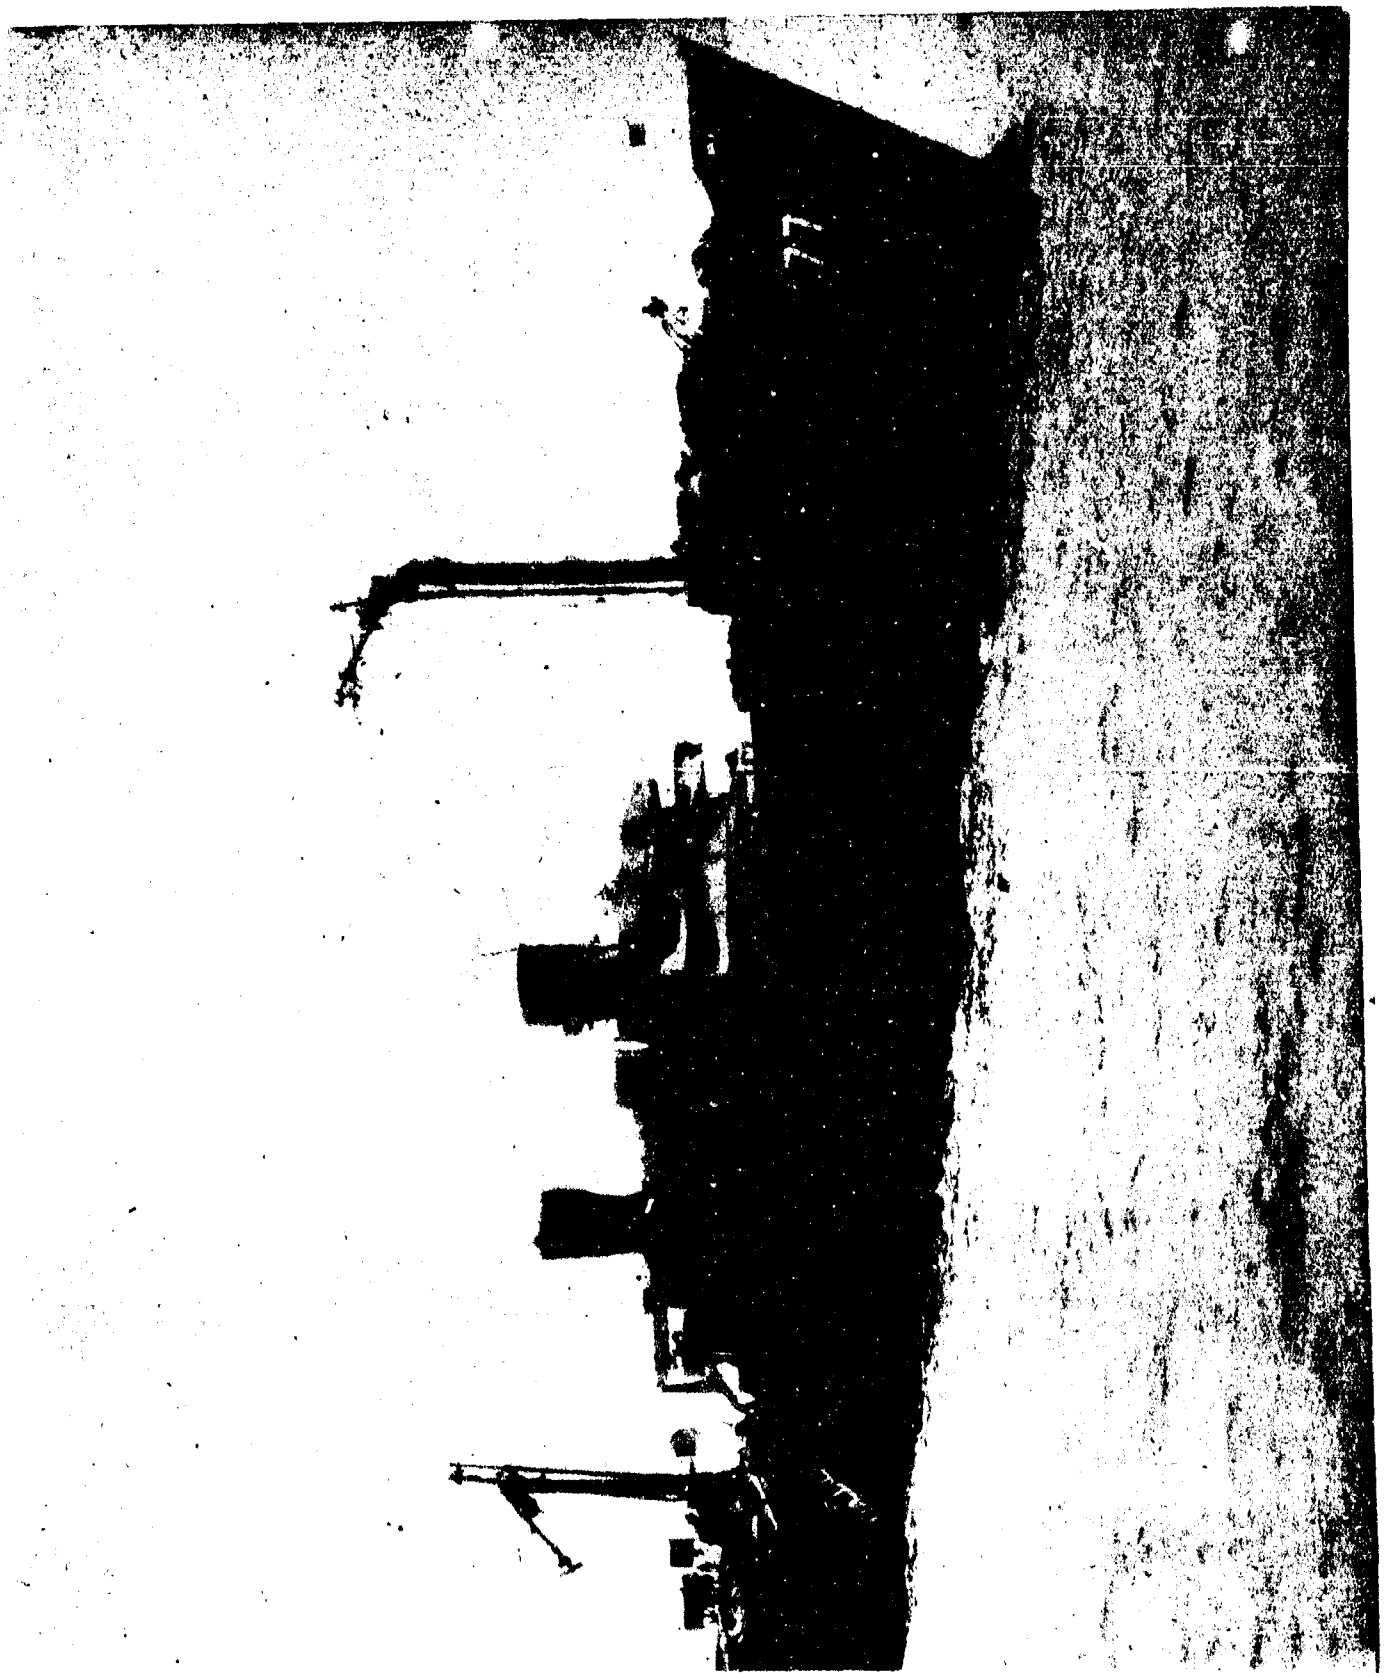
AA-CR-227-49-117. USS CRITTENDEN (APA77). General view of blast damage to superstructure - starboard bow view.

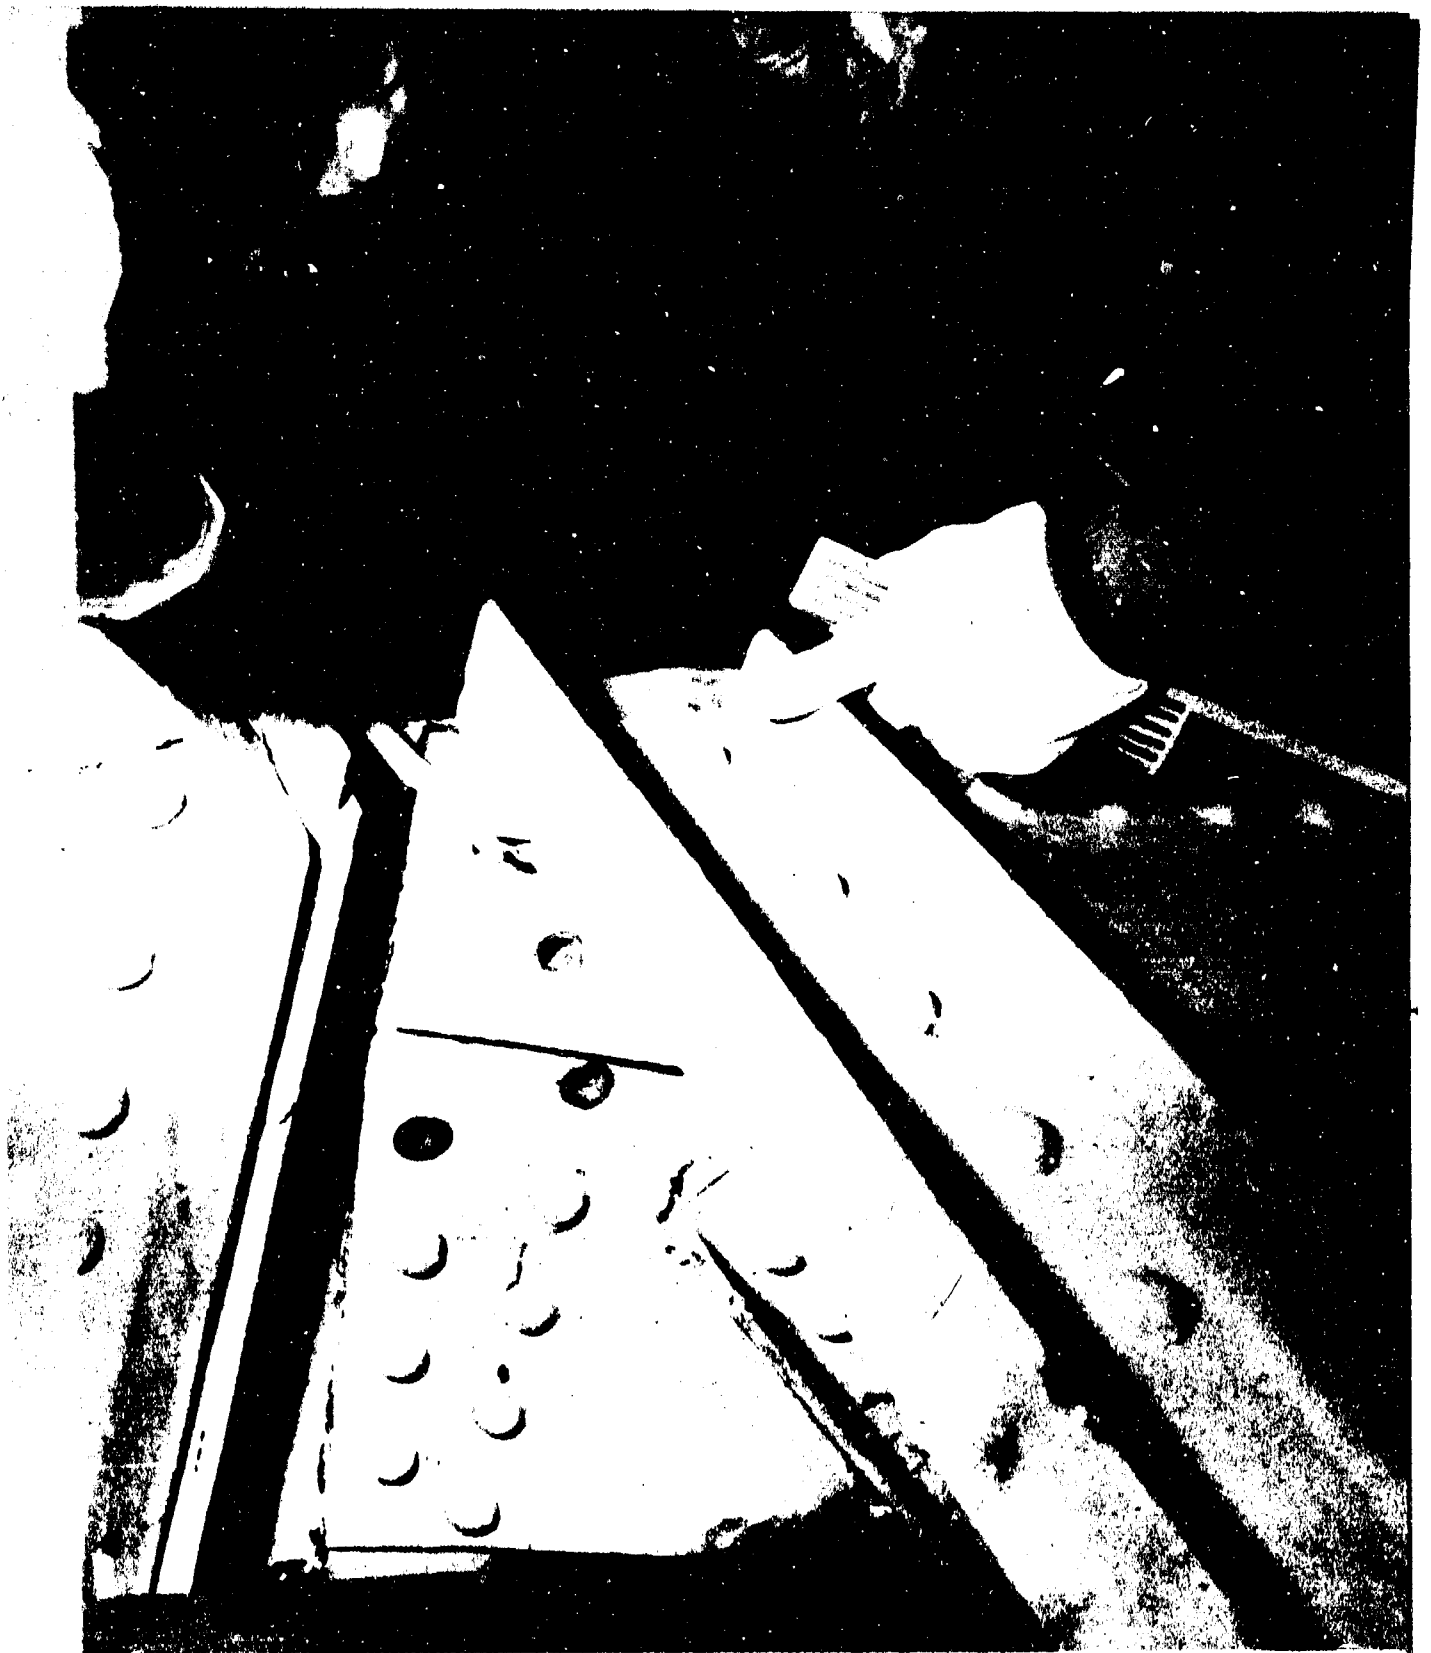
AB-CR-68-1691-8. USS PENSACOLA (CA24). Failure of port main condenser foundation due to underwater shock. Note sheared rivets. Forward engine room, forward face of after end of foundation.

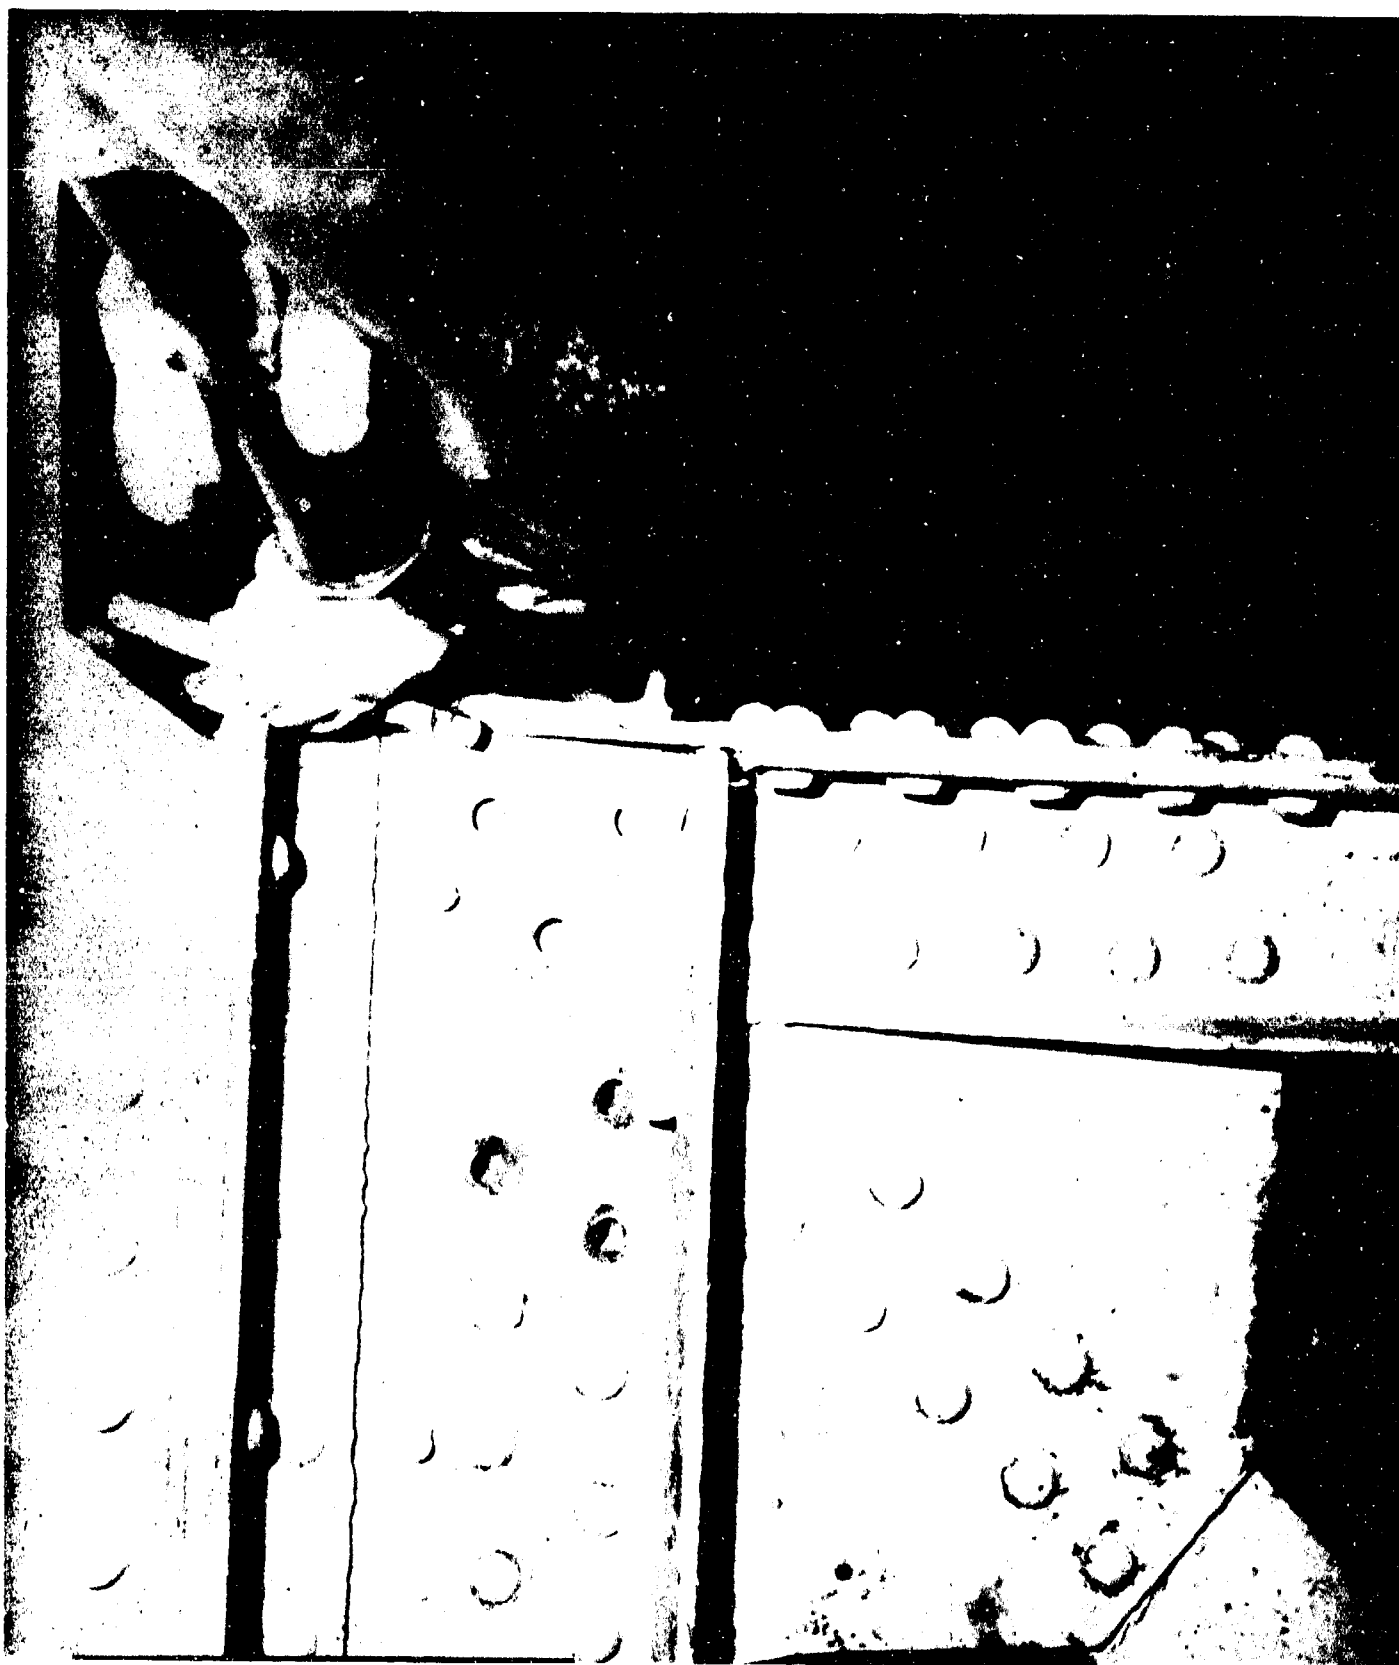
AB-CR-68-1691-5. USS PENSACOLA (CA24). Failure of forward end of port main condenser foundation due to underwater shock. Note sheared rivets.

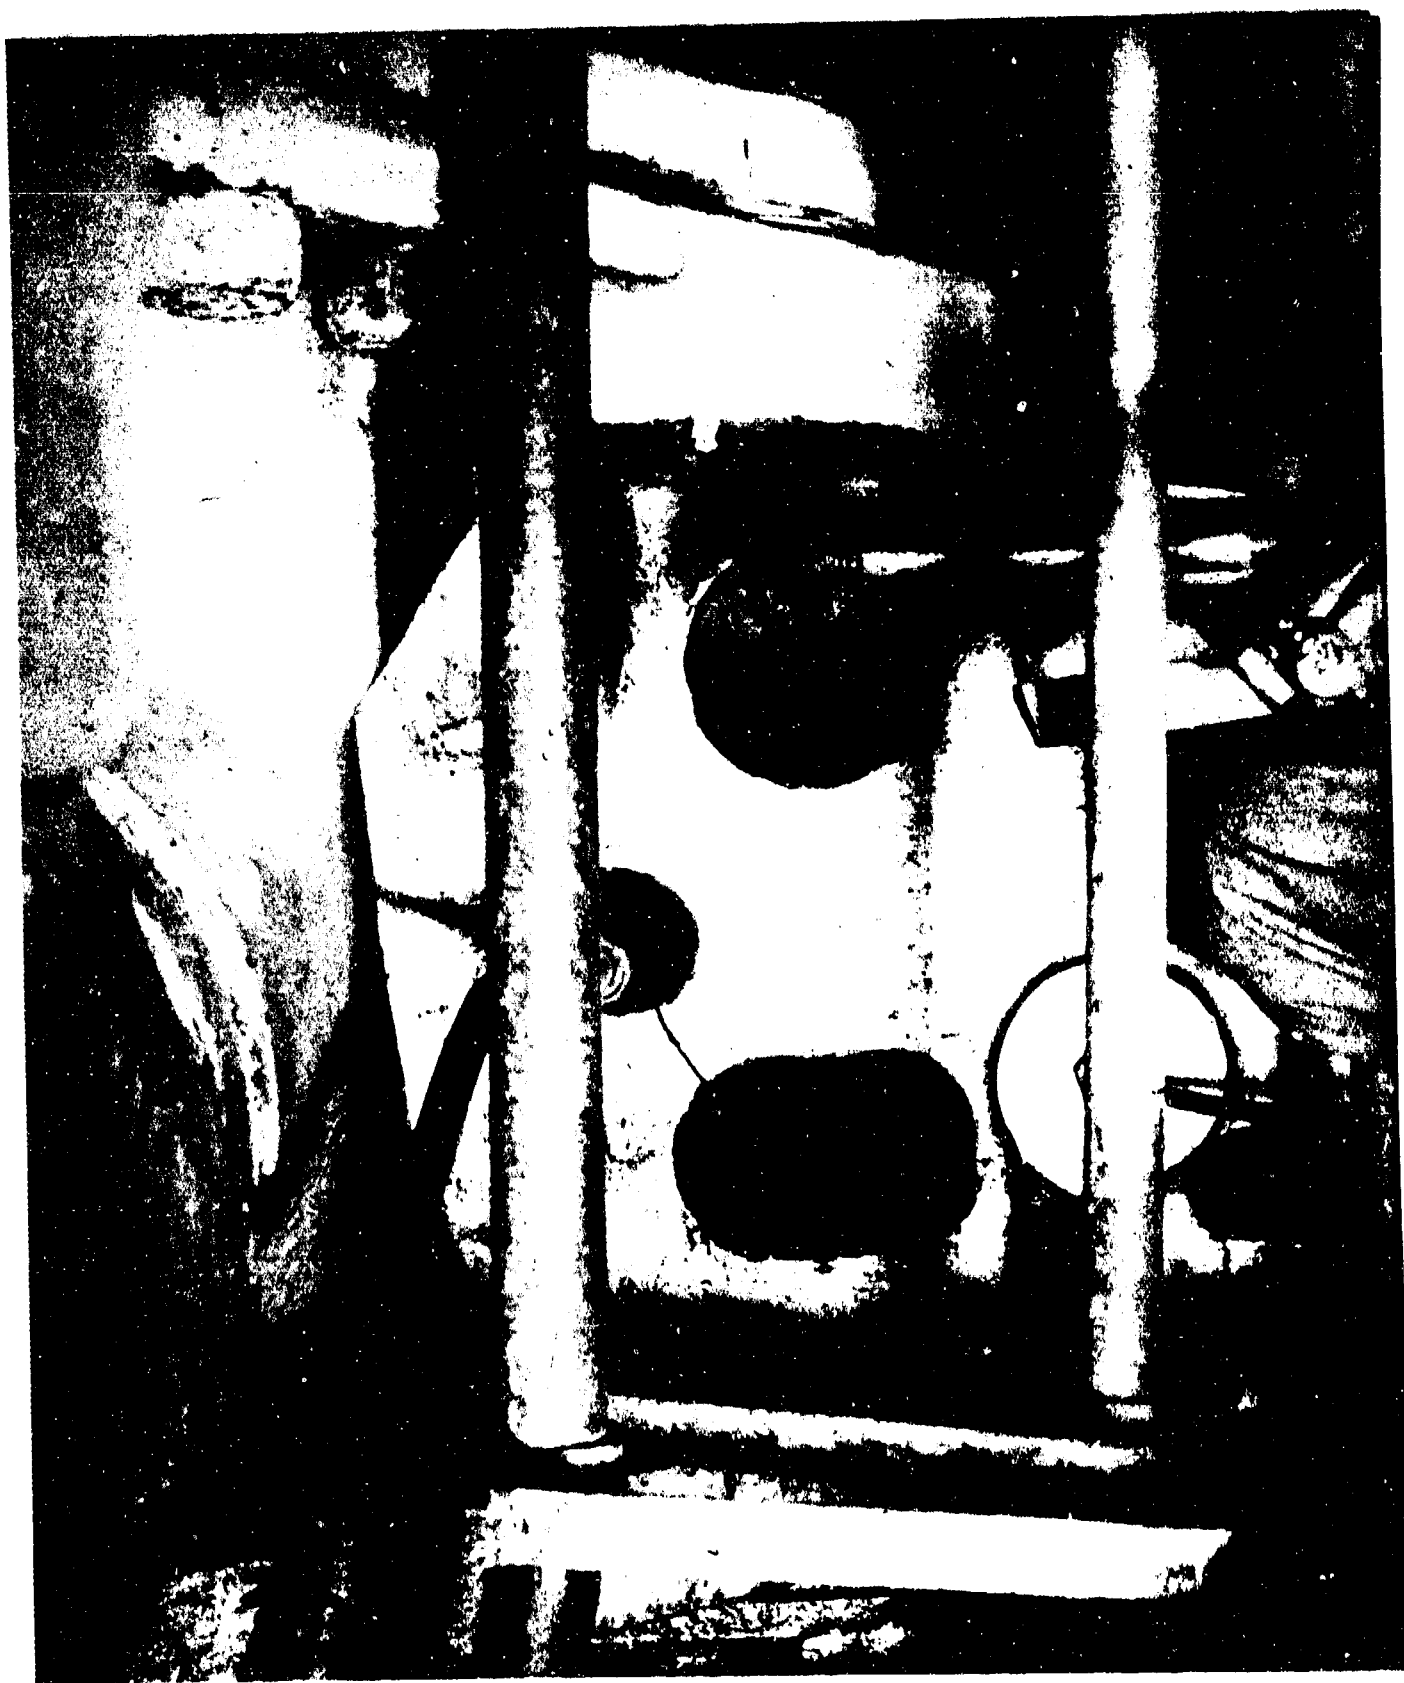
AB-CR-82-4226-2. USS PENSACOLA (CA24). Fracture in cast iron mounting feet of No. 1 L.P. Turbine. Shock damage.

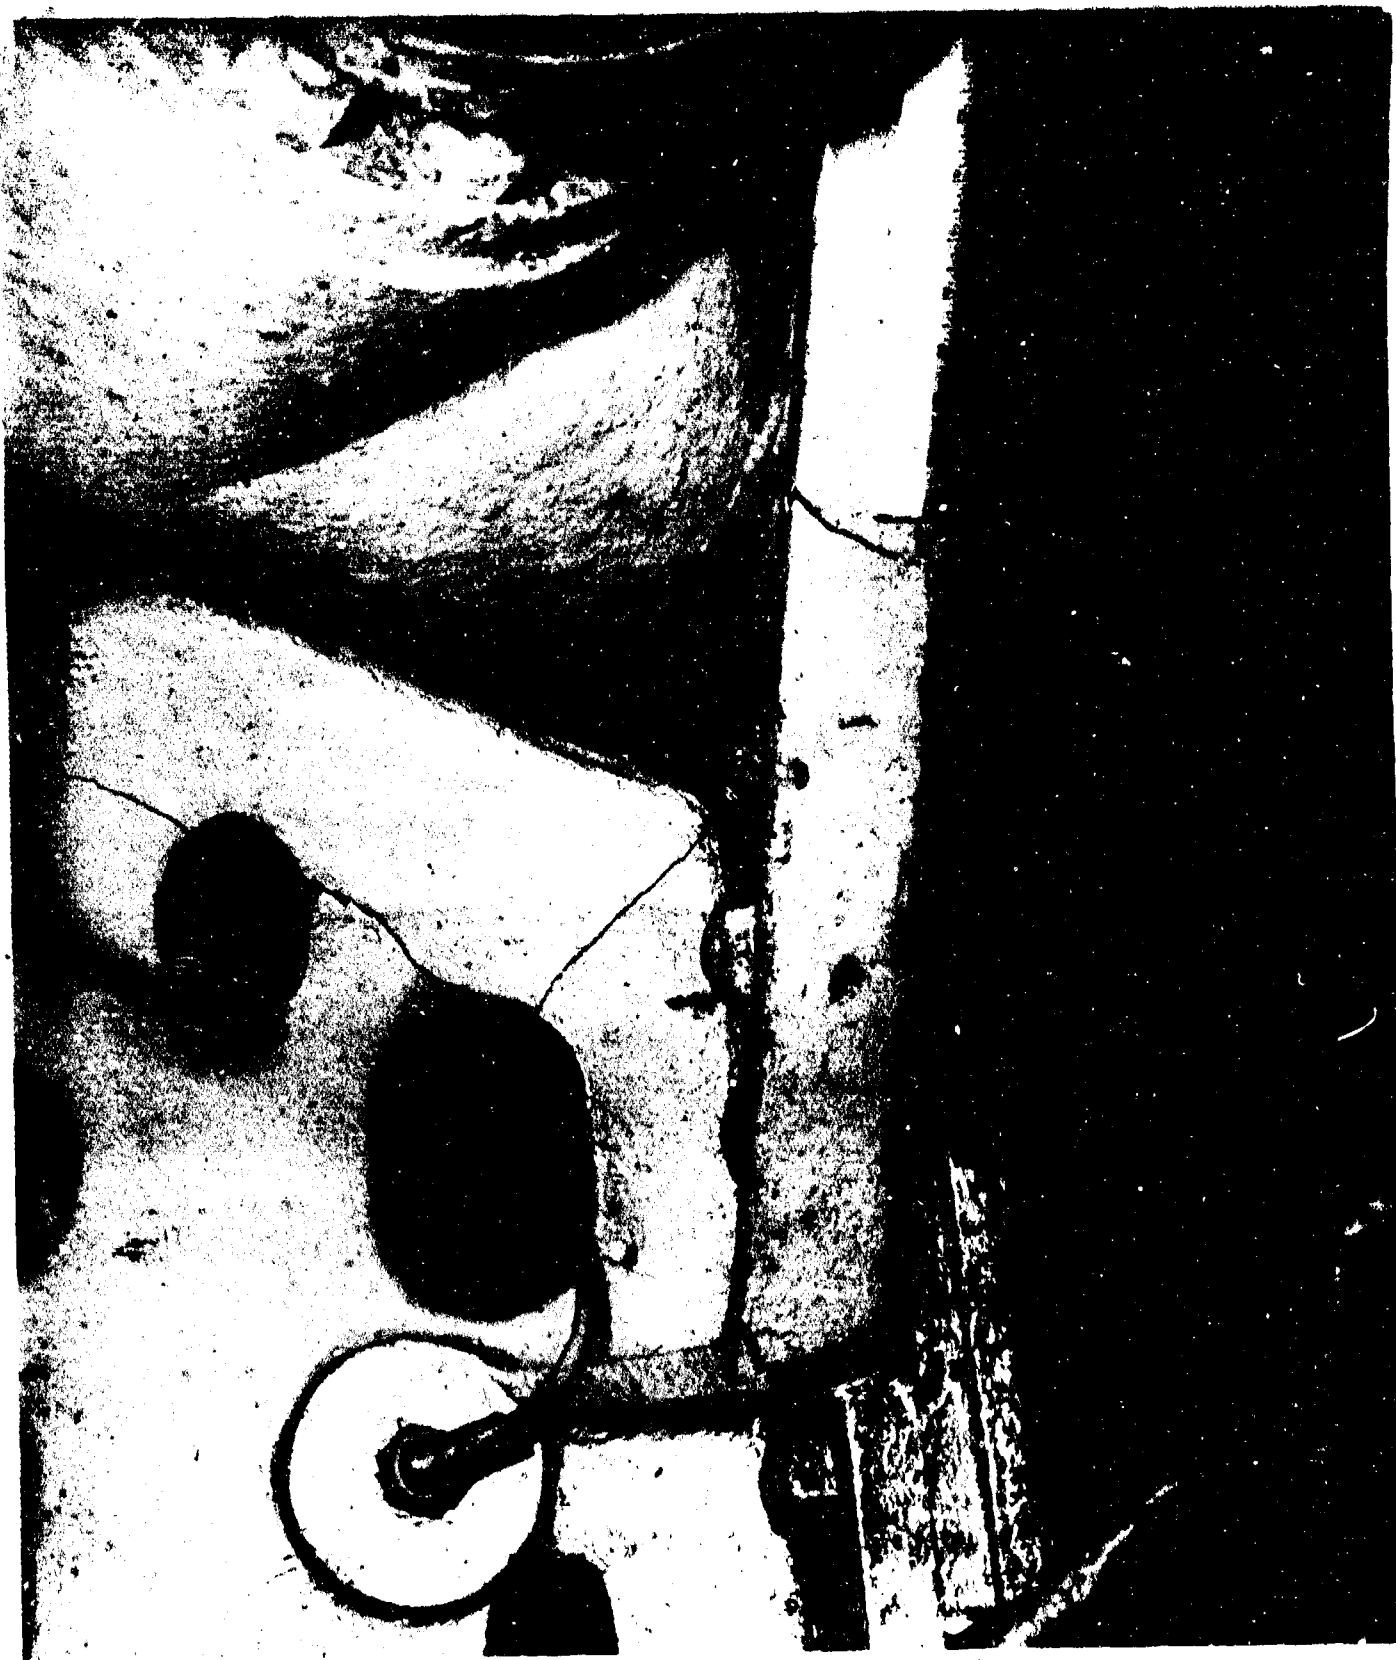
AB-CR-82-4226-5. USS PENSACOLA (CA24). Fracture in cast iron bracket and flange of casing on aft end of No. 4 L.P. turbine. Shock damage.

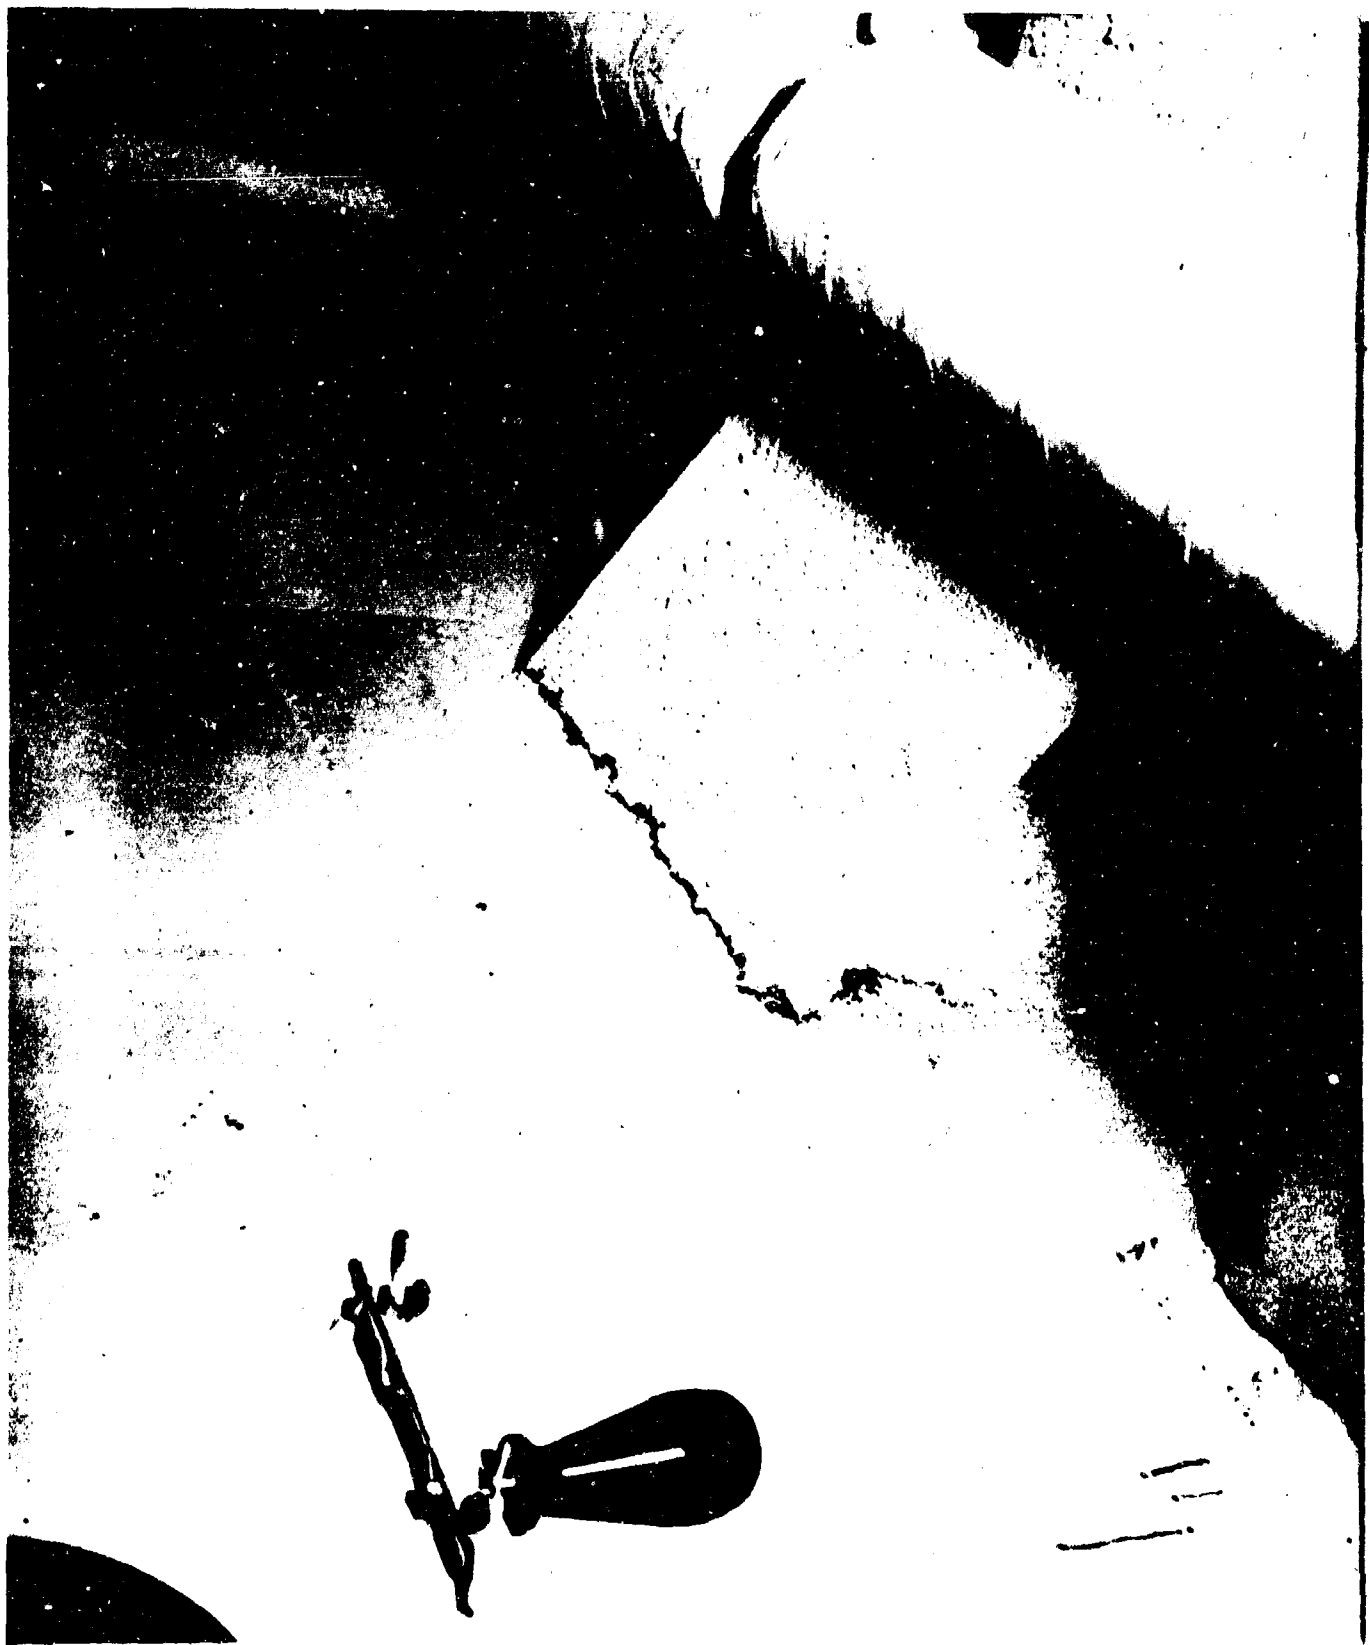
AB-CR-76-2083-11. USS FALLON (APA81). Failure of welded connection at intersection of deck longitudinal with transverse structural bulkhead. Underwater shock damage. Bulkhead 124, looking forward and upward from main deck.
